**Preassessment Screen for the Chino,
Tyrone, and Morenci Mine Sites,
Grant County, New Mexico, and
Morenci, Arizona**

PREASSESSMENT SCREEN DETERMINATION

This document contains three distinct parts, corresponding to each of the three mines, preceded by an executive summary. Part A focuses on the Chino Mine, Part B focuses on the Tyrone Mine, and Part C addresses the Morenci Mine. Each part is organized using a consistent structure: Chapter 1 introduces the intent of the preassessment screen and criteria to be addressed; Chapter 2 provides information on the site; Chapter 3 provides a preliminary identification of resources at risk; Chapter 4 presents an assessment of each of the determination criteria; and Chapter 5 provides references cited.

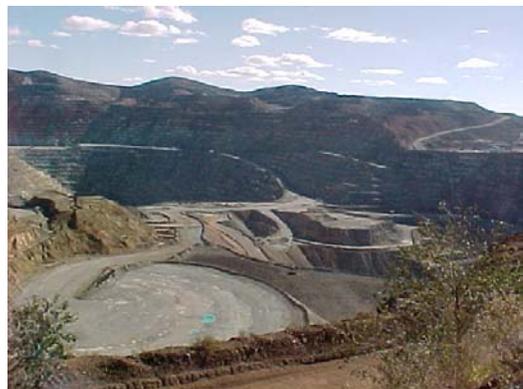
Figure 2.4. Santa Rita open pit at the Chino Mine in October 2002.

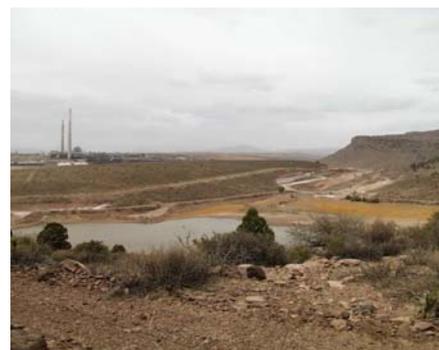
Figure 2.5. Hurley smelter at the Chino Mine (in background).

In 1911, a mill and concentrator were built near the current Hurley smelter site. Grinding and flotation were used to increase the copper concentration before transporting the ore for smelting. In mid-1982, a new mill and concentrator (called the Ivanhoe concentrator) near the open pit replaced the original Hurley mill and concentrator. The Hurley smelter was completed in 1939 (Figure 2.5). Tailings from the concentrators are deposited east of Hurley along Whitewater Creek.

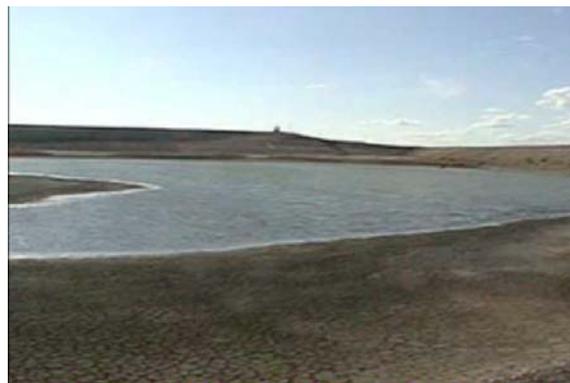
Consequently, after precipitation events, ponded water in contact either with oxidized tailings or with contaminated sediments in Axiflo Lake and Lake One can serve as a pathway of hazardous substances to birds and wildlife attracted to ponded water in the arid Southwest (Figure 2.7). The ponds are intermittent, depending on precipitation and evaporation rates, but remain a source of future releases after periods of surface water accumulation.

Figure 2.7. Water ponded on the surface of tailings.

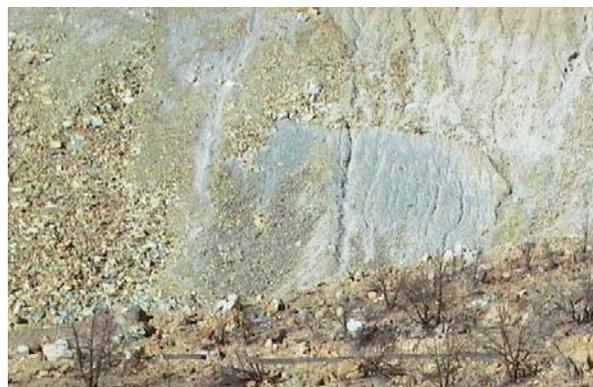
Near the Santa Rita pit, stockpiles used for leaching encompass approximately 1,700 acres in five piles, and waste rock stockpiles encompass approximately 340 acres in seven stockpiles (Table 2.5). In addition, four small stockpiles with a total area of approximately 2.4 acres are located along upper Whitewater Creek. Releases of hazardous substances, including but not limited to cadmium, copper, lead, and manganese, from stockpiles at the site have been multiple and at times continuous, most likely beginning at least from the start of leaching operations of low-grade ore stockpiles near the open pit in 1936 (M3, 2001, p. 2-2) and extending to the present. Multiple surface piles of waste rock and leach stockpiles at the Chino Mine are able to serve as continuous sources of hazardous substances through 1) releases of PLS from leach stockpiles, 2) acidic seepage from acid-mine drainage at waste rock piles, and 3) precipitation-induced erosion, storm-water runoff, or windblown emissions from waste rock and leach stockpiles. An example of erosion on a leach stockpile is shown in Figure 2.8. Some releases of hazardous substances into groundwater may be captured by pumping of the Santa Rita pit, if the direction of groundwater flow is toward the pit.

Figure 2.8. Erosion at the Lampbright leach stockpile at the Chino Mine.

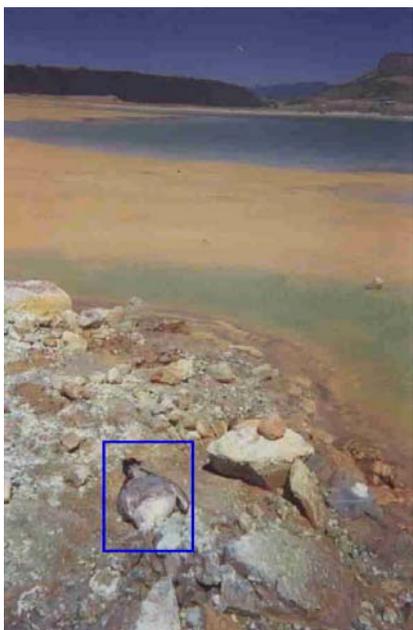
Figure 3.3. Dead ring-billed gull found at Lake One in September 2000.

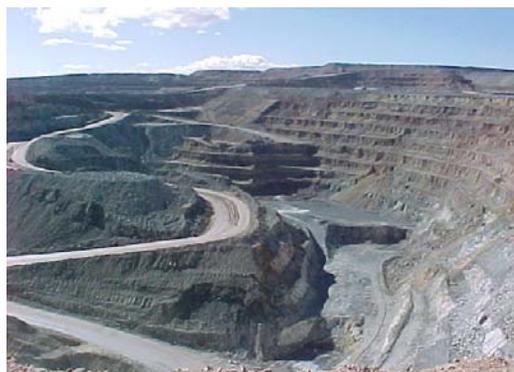
Figure 2.3. Tyrone open-pit mine in October 2002.

In the late 1870s through the early 1900s, a number of companies mined turquoise, copper, and fluorspar in the Tyrone Mine area. The Phelps Dodge Corporation (Phelps Dodge) consolidated the mining claims in the area by 1913 and developed a large-scale underground operation that shut down in 1921, with sporadic operations from 1921-1929 and 1941-1950. The Tyrone Mine and the SX/EW facility are currently operated by PDTI, which is wholly owned by Phelps Dodge (U.S. Securities and Exchange Commission, 2002). The current Tyrone Mine facility is an open pit copper mine (Figure 2.3).

Open pit mining began in 1967, when excavations were made to expose and mine the ore. By September 1969, 95 million tons of overburden had been removed from the Tyrone pit to allow the mining of copper ore to begin (SARB, 1999, p. 4). The Tyrone pit has been developed with 50 foot benches, with gradients of 1.3 feet horizontal to 1 foot vertical (M3, 2001, p. 2-19). In February 1999, the Tyrone open pit was approximately 1,400 feet deep and covered an area of about 1,400 acres (M3, 2001, p. 2-19). Parts of the pit have been partially or completely backfilled. The pit is actively dewatered, which induces groundwater flow toward the pit (M3, 2001, p. 2-7).

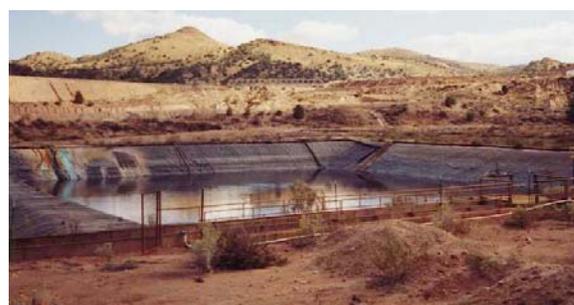
Figure 2.5. PLS collection pond at the Tyrone Mine.

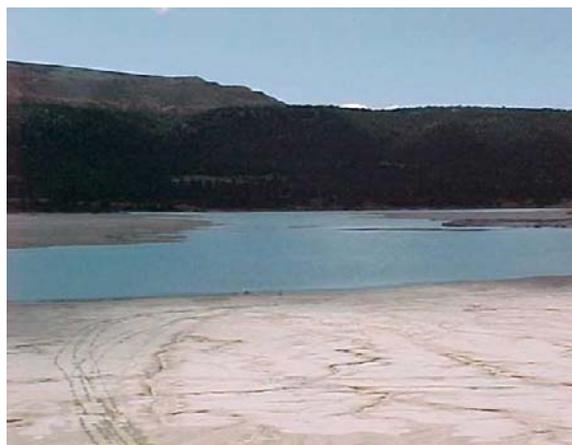
The six unlined tailings impoundments in the Mangas Valley contain acid-generating materials. The Supplemental Materials Characterization (Daniel B. Stephens & Associates, 1997c) found that the average acid-base accounting (ABA) for the Nos. 1A and 2 tailings ponds were -38.9 and -26.7, respectively, indicating significant acid-generating potential. As water drains from the tailings, the upper portions of the tailings ponds are exposed to the atmosphere, causing the oxidation of sulfide minerals. As precipitation ponds on the surface of the tailings impoundments and interacts with these upper oxidized tailings, the concentration of metals, total dissolved solids, and sulfate in the water will increase, while pH will decrease.

Figure 2.6. Water ponded on the surface of Tailings Pond #1A in October 2002.

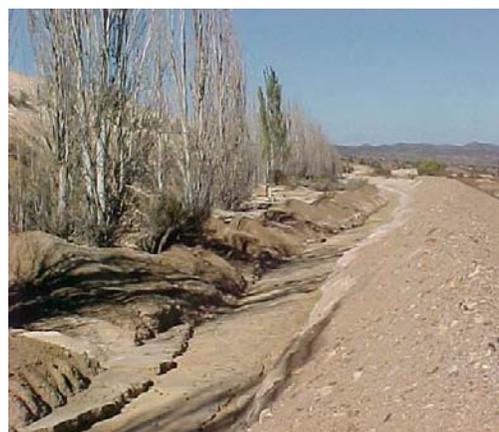
Multiple surface piles of tailings are able to serve as continuous sources of hazardous substance releases through 1) precipitation-induced erosion, storm-water runoff, and windblown emissions from tailings; 2) formation of surface water on tailings ponds in response to precipitation events; and 3) multiple spills of tailings. An example of erosion of tailings into the area surrounding the Mangas Creek, observed in October 2002, is shown in Figure 2.7. In 1989, the report of a tailings pond inspection by the New Mexico Health and Environment Department noted serious erosion of tailings materials at Dam #3, resulting in gullies more than 10 feet deep and 5 feet wide, as well as erosion of the reclaimed area near Dam #3 that had been covered with top soil following the 1980 tailings spill (Dye, 1989). An inspection in 2001 noted rills, gullies, and exposed tailings in the same area (Phillip and Reed, 2001). We did not review any information measuring windblown deposition of tailings on soils or in ephemeral waterways, but this deposition is likely given the large surface area of uncovered tailings impoundments.

Figure 2.7. Tailings eroded into the channel above the Mangas Creek. A row of dead cottonwood trees is adjacent to the tailings.

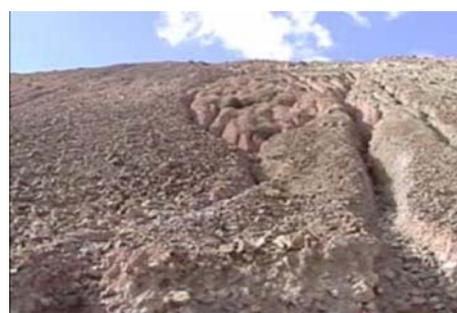
start of copper recovery in 1969 and extending to the present. Multiple surface piles of waste rock and leach stockpiles at the Tyrone Mine are able to serve as continuous sources of hazardous substances through 1) releases of PLS from leach stockpiles, 2) acidic seepage from acid-mine drainage at waste rock piles, and 3) precipitation-induced erosion, storm-water runoff, or windblown emissions from waste rock and leach stockpiles. An example of precipitation-induced erosion on a leach stockpile is shown in Figure 2.8.

Figure 2.8. Gully erosion on the No. 3 stockpile at the Tyrone Mine.

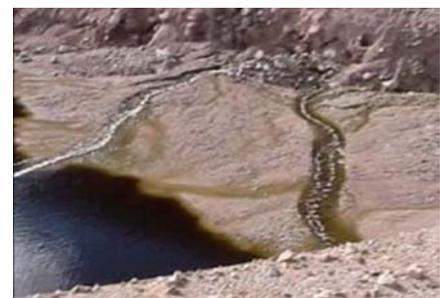
The SX/EW plant is associated with uncovered collection ponds for the PLS and a system of pipes to pump the PLS to the SX/EW plant. These uncovered ponds serve as ongoing sources of hazardous substances to wildlife that may come into contact with the ponds (Figure 2.9). Plant releases and upsets from the SX/EW plant and associated infrastructure have resulted in intermittent releases of hazardous substances into the environment, including spills of raffinate and PLS (Table 2.5). Table 2.5 gives a chronology of spills and releases at the Tyrone Mine from 1997 to 2002 associated with the SX/EW plant and infrastructure, based on documents in the State of New Mexico’s administrative record for groundwater discharge permits at the Tyrone Mine. Additional spills and releases are likely to have occurred before and after this time period.

Figure 2.9. PLS entering uncovered pond at the No. 3 stockpile at the Tyrone Mine.

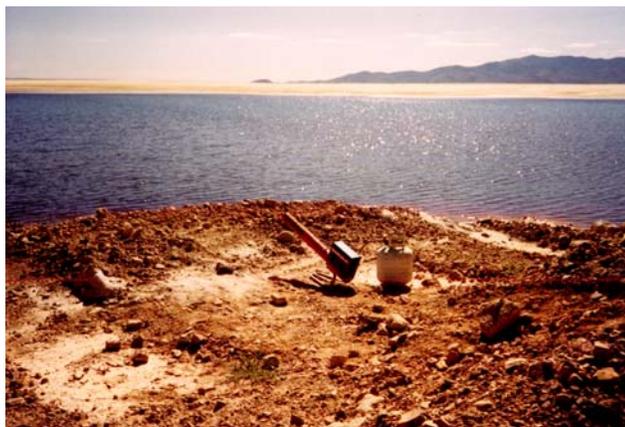
Comparisons of hazardous substance concentrations in invertebrate samples collected from reference sampling locations at the nearby Chino Mine with invertebrate samples collected from Tyrone Mine tailings ponds provide further evidence of exposure pathways at the Tyrone Mine (Tables 3.3, 3.4). For example, copper concentrations in unrinsed invertebrate samples from the Tyrone Mine tailings ponds were 75 to 442 times greater than mean copper concentrations in reference samples from the Chino Mine. Birds, reptiles, or mammals that ingest invertebrates with high concentrations of hazardous substances at the Tyrone Mine tailings ponds would be exposed to these substances.

Figure 3.3. Hazing cannon at a Tyrone Mine tailings pond, October 2002.

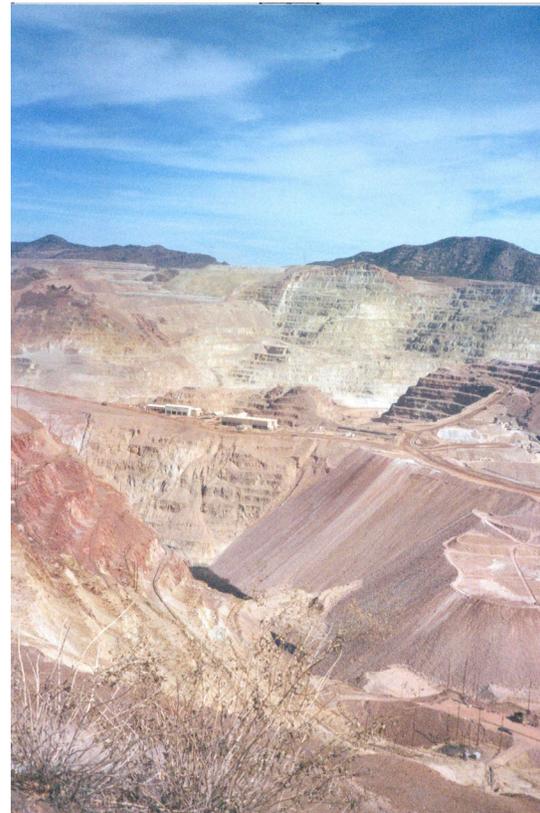
Figure 2.4. Morenci Mine open pit, February 2003.

In 1997, the Morenci Mine open pit mine complex comprised 3,055 acres (Table 3 in PDMI, 2002) (Figure 2.4). Ore is mined from the pit using conventional drill, blast, load, and haul techniques (PDMI, 2002, p. 7). In 2002, ore was mined from the Metcalf, Northwest Extension, and Coronado areas of the open pit. In 2001, ore was mined from the Southside and Garfield areas. Future mining is planned in the Western Copper, Southside, and Garfield areas of the pit.

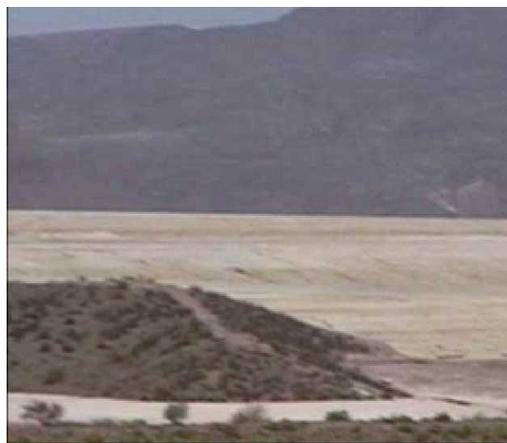
Tailings facilities are large volume storage areas impounded by embankments (Figure 2.5). There are five tailings complexes in the Morenci District, including the Southwest 1, Southwest 2, Silver Basin, West, and East tailings dam complexes (Table 1 in ADEQ, 2002) (Table 2.2). All are located in the southern part of the Morenci District. Tailings deposition in the Southwest, Silver Basin, and West tailings impoundments reportedly will continue until the concentrators are closed (PDMI, 2002, p. 17); however, the concentrators are on standby since PDMI switched all mining to mine for leach in 2001. The East Tailing Dam complex is currently inactive (PDMI, 2002, p. 17).

Figure 2.5. Tailings pond outer embankment at the Morenci Mine.

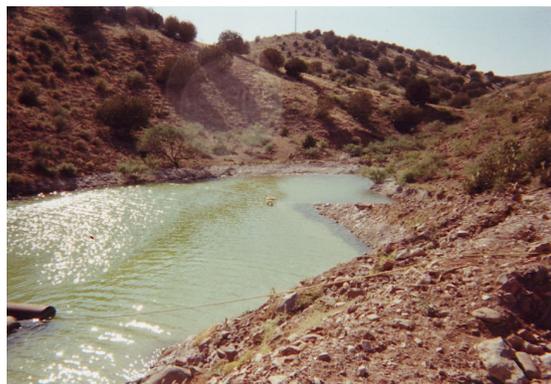
Information on rates, volume, and content of hazardous substances eroded from the tailings impoundments was not available for review for this preassessment. However, during a site visit in October 2002, USFWS personnel were informed by PDMI personnel that stormwater retention pond 7A, which is approximately 800 feet downgradient of Southwest 1 Tailing Dam, is periodically dredged to remove accumulated tailings to maintain its stormwater holding capacity (USFWS, unpublished data) (Figure 2.6). PDMI's APP specifies annual removal of tailings accumulated behind stormwater retention dams as an operational requirement (ADEQ, 2000, 2002), further indicating that hazardous substances present in tailings are released to the environment through stormwater runoff.

Figure 2.6. Morenci Mine stormwater retention pond at Dam 7A, October 2002.

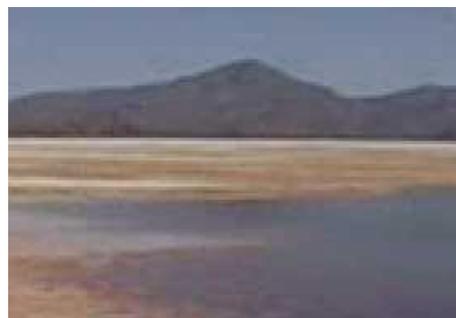
Figure 2.7. Ponded water on tailings at the Morenci Mine.

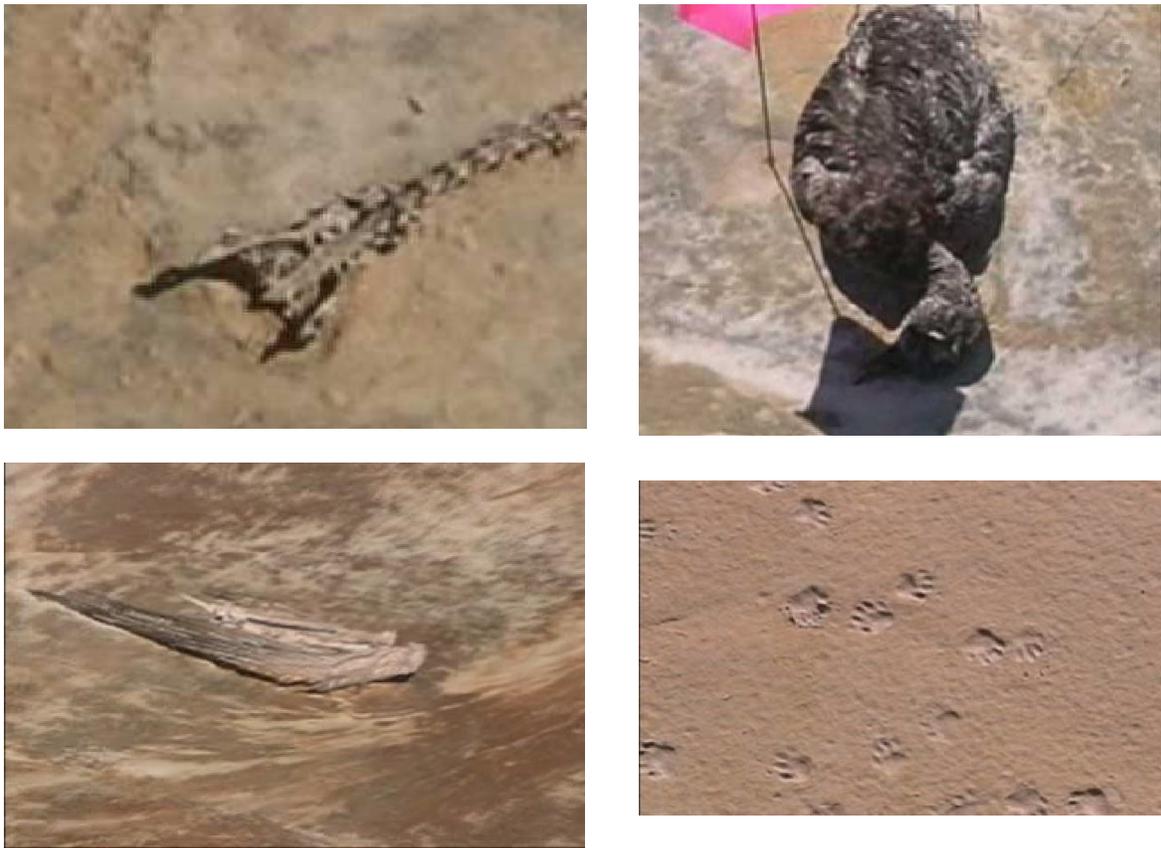
Figure 2.8. Evidence of bird and wildlife use at the Morenci Mine tailings impoundments. Clockwise from upper left: animal spine, dead waterfowl, animal tracks, and bird wing.

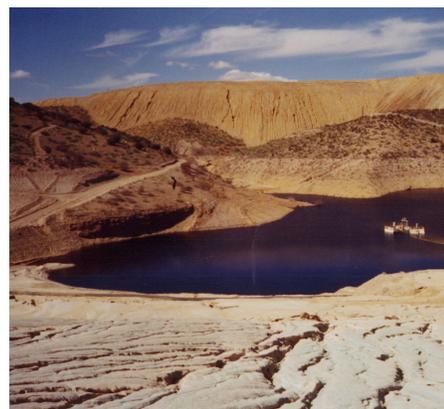
Figure 2.9. 23/25 MM PLS collection pond at the Morenci Mine.

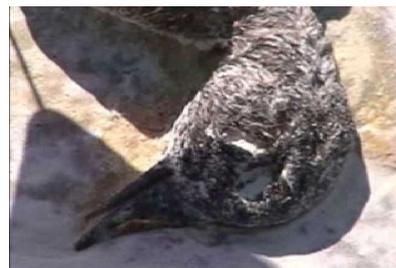
Figure 3.3. Close-up of dead bird found at the Morenci tailings in October 2000.

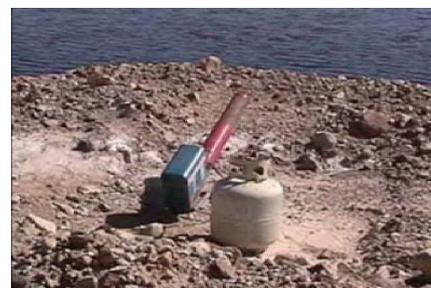
Morenci Mine has a hazing program for birds (Figure 3.4), indicating bird contact with ponded water on tailings is not uncommon.

Figure 3.4. Hazing cannon at a Morenci Mine tailings pond.
